Safety Advice

The Issue

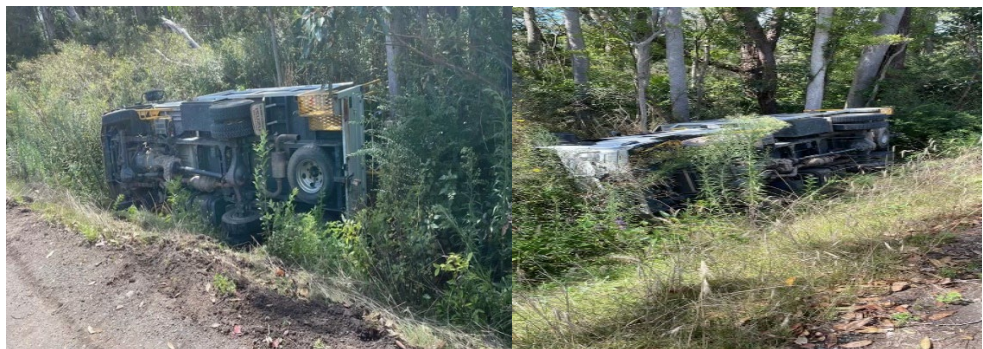
An electrical crew were travelling to a worksite using a narrow council access road. There were two employees in the truck (Isuzu MPR 300). The truck has driven onto soft road edges resulting in the truck sliding down the embankment and rolling onto its side. The two employees were not injured.

- The access road has been recently upgraded and the fence had been reinstalled in a different position. The employees had not driven on this road since the upgrade.
- The access road was narrow (2.33m) causing the driver to move away from the fence which resulted in the right front right wheel coming off the road and onto soft shoulder.
- The driver tried to correct this by stopping and adjusting however the weight of the truck shifted, and the truck slid down further and rolled onto its side.
- The ground was very wet after recent weather events.

- Team briefings on the importance of assessing vehicle routes, particularly if road or route is new or conditions have changed.
- Sign to be installed at the access point - (No Sydney Trains vehicles beyond this Point)
- Inform Local Council of issue.
- An investigation into the incident is currently underway to identify any other causal factors that may have contributed.
