**weekly notice**

Monday, 11 December 2017  
Sunday, 17 December 2017

## **TRAIN EXAMINATIONS – EXTRA PRECAUTIONS DURING THE WOLO RISK PERIOD (OCTOBER TO MARCH)**

## **HORNSBY – COMMISSIONING OF HORNSBY JUNCTION REMODELLING**

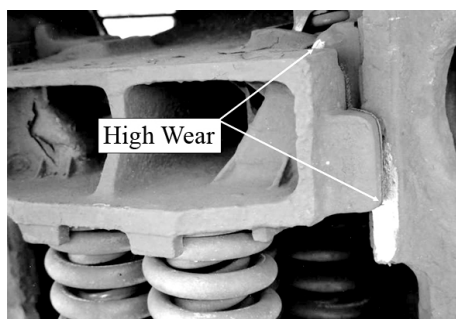
- fresh bolster gib wear (see Figure 1)
- wear between the side of the friction wedge and bolster pocket (see Figure 1)
- fresh wear between the axle box or the bearing adaptor and bogie side frame
- melting of plastic elements in the constant contact side bearers due to friction heating (see Figure 3).

**Figure 1:** High gib/side frame wear and friction wedge lateral wear

Freight wagons with the following hunting defects should be marked off, or reduced to 50km/h maximum speed, when a WOLO has been declared.

Freight vehicles showing any of the above defects should be marked off, or operate at reduced speed until corrective action is taken.

The reduced speed shall be the maximum permitted track speed not exceeding 50km/h when a WOLO has been declared.

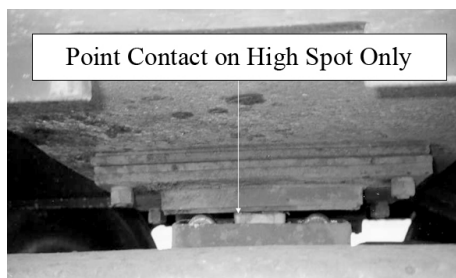
Check for wear of non-metallic components, and that the side bearers are seating correctly with no gap (see Figure 2). This applies mainly to freight, but also applies to passenger rollingstock such as NHA bogies under XPT and J type bogies under S, K and C sets.

**Figure 2:** Constant contact side bearer with point contact

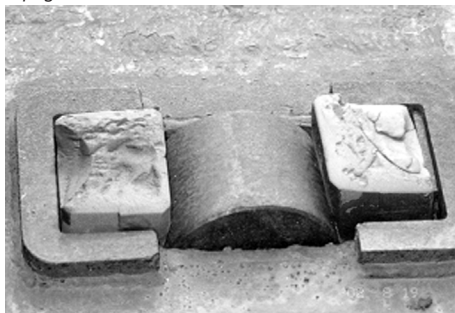
**Figure 3:** Constant contact side bearers with melted plastic blocks
