Safety Alert

Sharing information to prevent incidents

The Issue

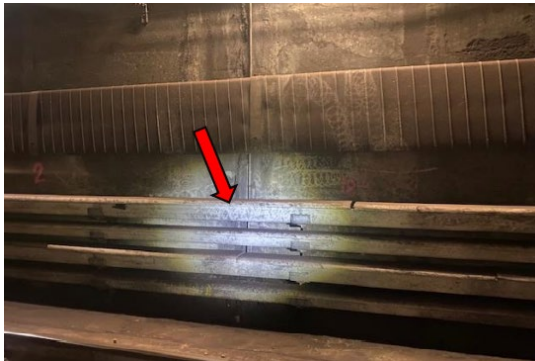
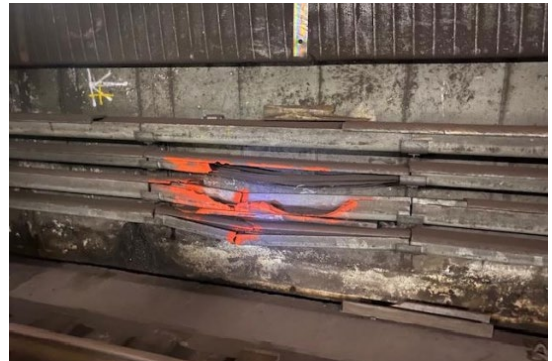
The ESR contains asbestos cement cable troughing as a legacy material used in its construction in the late 1970's. A recent inspection conducted prior to cabling works has identified the presence of asbestos containing dust within the troughing at various locations.

- An inspection discovered that asbestos dust is present within the ESR asbestos containing troughing.
- No airborne asbestos has been detected adjacent to the troughing.

Asbestos containing troughing within the ESR.

- Engage with an external asbestos hygienist to assist in undertaking the appropriate risk assessment for your works to ensure the safety of your team and legislative requirements are met.
- No works are to be undertaken on the ESR asbestos containing troughing unless appropriate task-specific controls have been implemented.
- Risks associated with asbestos and hazardous materials are managed using procedure in Sydney Trains' Safety Management System (SMS) procedures [SMS-06-OP-3034 - Manage Risks with Hazardous Materials](#) and [SMS-06-OP-3045 - Managing Asbestos Work](#).
