Safety Alert

The Issue

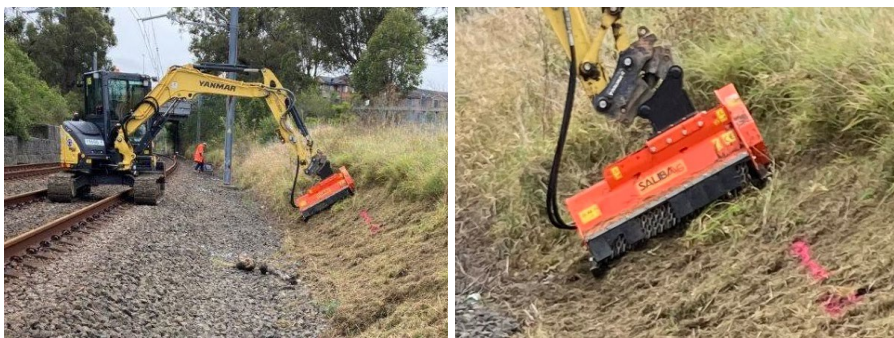
A worker sustained a serious injury to their shin when a piece of ballast was discharged by a mulching head attachment on an excavator. The exclusion zone listed on the SWMS did not align with the exclusion zone recommended by the manufacturer of the mulching head. The worker was standing within the limits of the exclusion zone at the time they were struck. The rubber protection strips on the mulching head were damaged and may have contributed to the incident. The condition of the equipment and suitability for the task will form part of the investigation.

A temporary suspension on work with mulching heads is in place until the investigation is completed and findings have been implemented.

- All hazards and control measures for works being undertaken are to be communicated to all workers during the pre-work brief at the start of the shift.
- SWMS and SWI are to align with the requirements of the plant manufacturer, and that, plant is to be operated in accordance with those requirements.
- The correct plant and equipment for the task will be used and in a serviceable condition. If this is not the case, work will cease, and the issue will be escalated to the relevant line manager.
- Damaged plant and equipment will be removed from service.
- Exclusion zones around plant and equipment will be implemented and maintained until the work is complete or positive communication has been received that work has paused.
- The appropriate Personal Protective Equipment (PPE) for the task as identified by the SWMS or SWI will be in use.
